Report of the Strategic Director, Department of Place to the meeting of the Bradford West Area Committee to be held on 20 September 2017

Derelict Buildings on Priestman Street, Bradford

This report has been produced for the Bradford West Area Committee to describe the condition of the buildings known as Lund Humphreys and Unit 71 on Priestman Street, Bradford and what actions can be taken to address the deteriorating condition of the buildings.

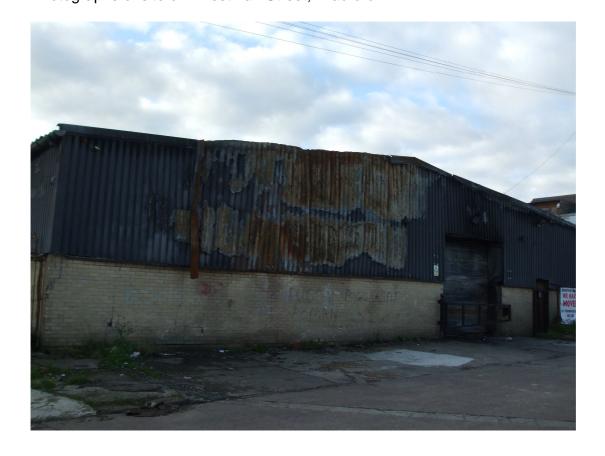
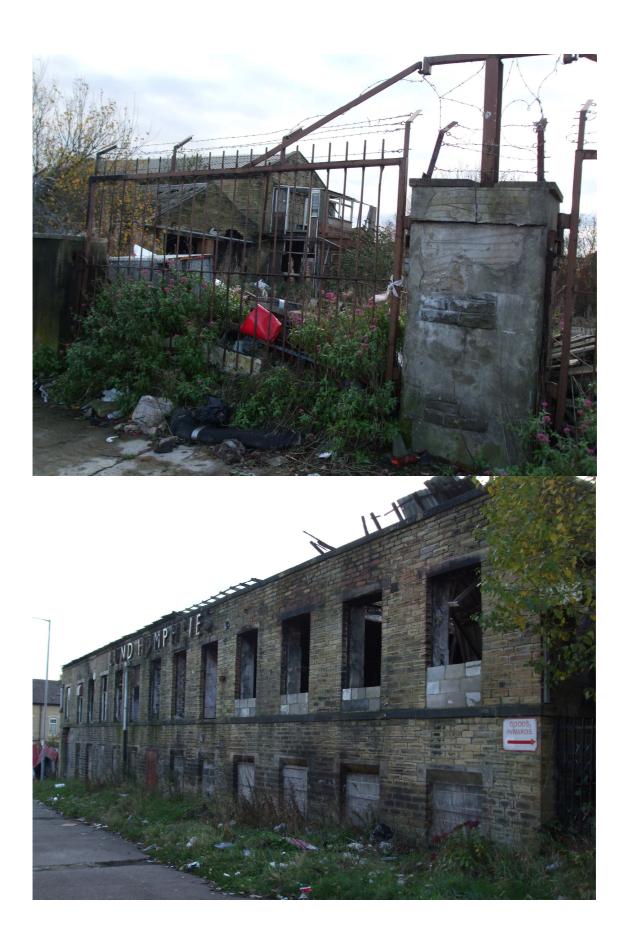
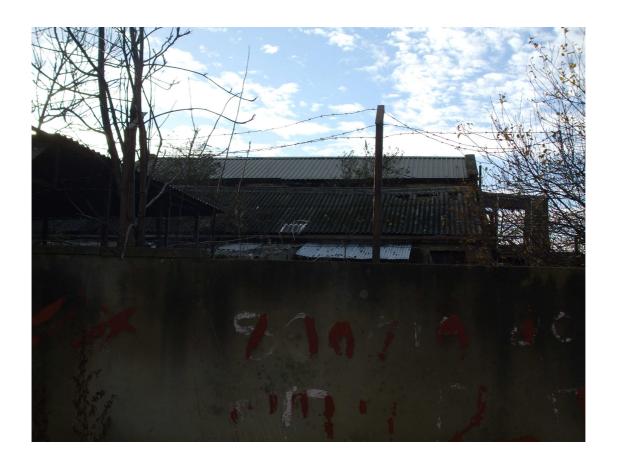
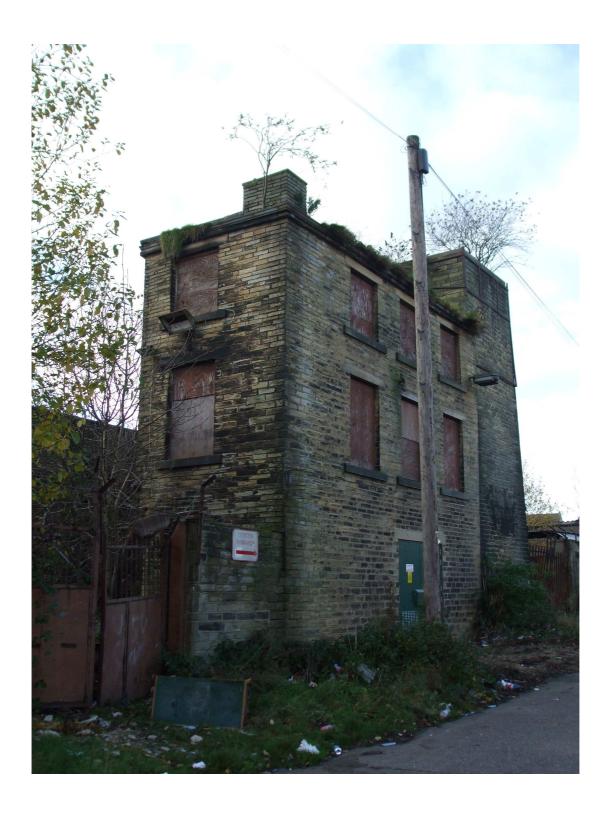
APPENDIX 1 Photographs of site on Priestman Street, Bradford.

- ➤ The former Lund Humphries Building and the adjacent unit 71 have been fire damaged in separate incidents and other than fencing off the site, the owner has carried out no remedial works.
- ➤ The majority of the roofs to the former Lund Humphreys building have been lost due to fire damage. Some of the floors remain and the majority of the wall structure is in place and is structurally stable in the medium term.
- ➤ The appearance and condition of the buildings and the owners' lack of progress in redeveloping or removing the remains causes a detriment to the appearance of the neighbourhood.

- ➤ The buildings on Priestman Street were badly damaged by fire. The buildings are not directly adjacent to the highway and do not present an immediate structural danger to the public. The sites have been fenced off to deter public access and, therefore, do not present an immediate danger to the public. However, trespassers onto the site will be at risk due to the deteriorating state of the remaining structures.
- > Trespassers onto the site have been prone to fire setting and the Fire and Rescue Service have attended on numerous occasions to extinguish small fires.

- ➤ The Council could leave the owners to clear and possibly redevelop the sites.
- ➤ The Council could use its powers under Section 79, Building Act 1984 or Section 215, Town and Country Planning Act 1990 to require the owner to restore or remove the buildings. In default of works by the building's owner, the council would determine the cost effective works to be carried out, fund such works and then seek to recover its costs.

That the council resolves to underwrite the costs and liabilities of carrying out works in default of notice to remedy the condition of the ruinous and dilapidated buildings on Priestman Street subject to the risks in recovering such expenditure.
